# HOME CONDITION REPORT

15225 Hardy St. Overland Park, KS

Inspection Date: 07/04/2005

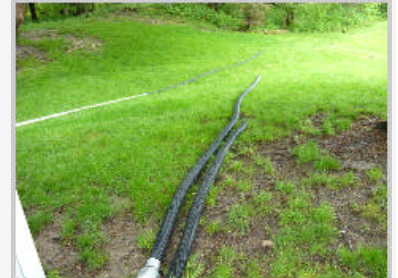
### 2.8 Site Drainage:

Action Necessary - There are areas of the lot that need adjustment to allow water to run off of the property. There are areas that may allow water to interfere with the foundation.

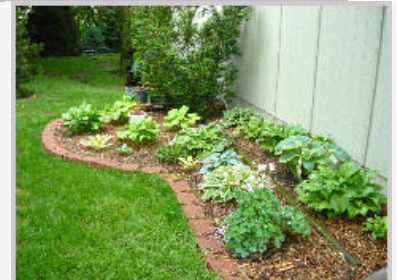
### 2.9 Bushes and Shrubs Condition:

Good - The shrubs and/or bushes have a better appearance than expected. They are neatly trimmed and spaced.

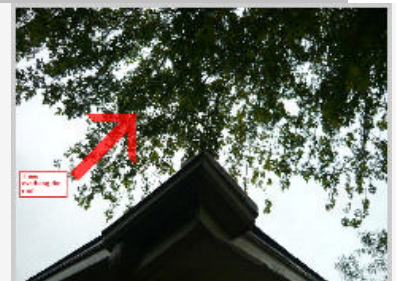
### 2.10 Trees Condition:

Trees overhanging the structure need to be trimmed so that limbs, leaves, and rain will not drop off the tree onto the roof covering and clog the gutters, damage the roof, or promote moss growth. Trees that rub against the roof can cause severe damage and can drastically reduce the life of the roofing material.

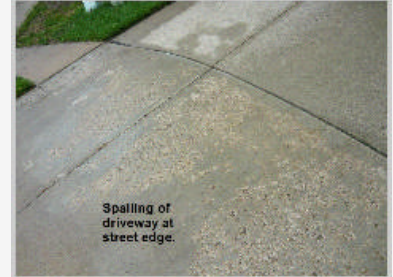
**2.13 Driveway Condition:**

Spalling - This is when the surface is flaking off. Although it is not necessarily a fatal condition, it may worsen over time. At some point you may want to replace sections for aesthetic purposes.

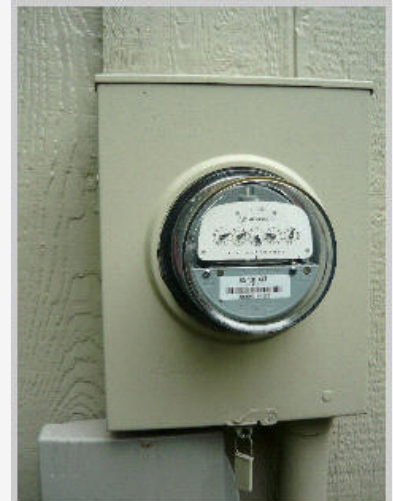
**2.19 Electric Service:**

Underground.

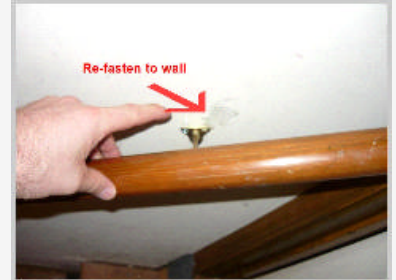
### 3.21 Staircase Condition:

Action Necessary - Action is necessary as the current staircase condition presents an unsafe condition or trip hazard. The hand rail on the right side needs to be re-fastened tightly into the wall.

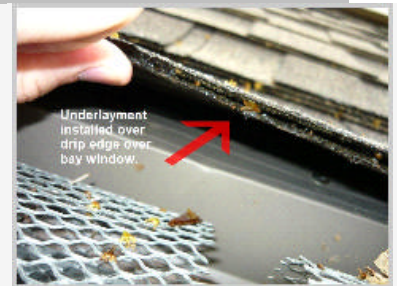
### 4.4 Underlayment Noted:

Asphalt impregnated felt underlayment was noted under the roofing material in at least 2 locations that were checked. **The bottom edge is tucked under the drip cap instead of on top over the bay window area. Another location was checked and the underlayment was installed over the drip edge which is the correct installation. This will force any water present to run behind the gutter wetting the fascia rather than falling into the gutter.**

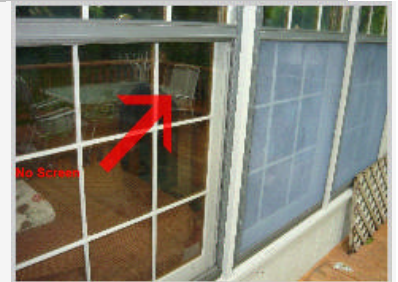
Attention Needed - One of the window screens installed over the deck need to be replaced.

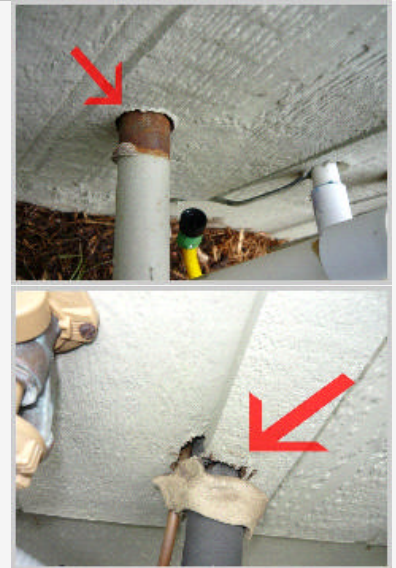
### 5.16 Structural Caulking:

Attention Needed - Several spots around the structure were noted that need to be caulked including the gas line penetration and the a/c line penetration into the home. Caulk should be applied to areas where brick and wood siding meet, trim around window frames or doors, and piping and service penetrations. Also, any cracks that allow moisture or wind entry should be caulked to prevent deterioration.

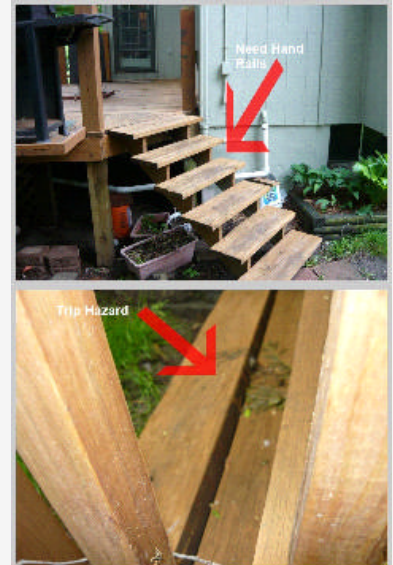
### 5.32 Stairs Condition:

Action Necessary - There is a trip hazard on the staircase leading into the middle of the yard on the last step. Repair is necessary. Use Caution. There is no handrail on the north staircase. Any staircase over 30 inches in height must have a handrail for safety reasons. This staircase is over 30 inches high and needs a handrail installed.

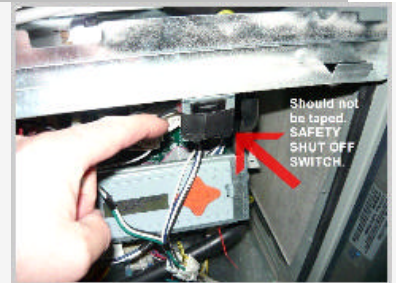
### 6.18 Heat Exchanger Inspected:

No, Equipment and controls which are part of the furnace block access to the heat exchanger. They must be removed to view the heat exchanger, which is beyond the scope of this inspection. Also noted was that the safety shut off switch was taped in a closed position. This switch kills the power to the unit when the access panel door is removed. This is a safety operation and should not be overridden by taping it in the closed position.

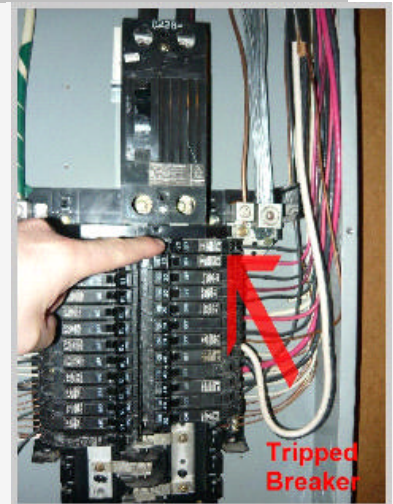
### 7.9 Breaker/Fuse to Wire Compatibility:

Satisfactory - The breakers/fuses in the main power panel appear to be appropriately matched to the circuit wire gauge. **We did note that upon opening the panel door, the top right breaker was tripped. What was controlled by this breaker is not known and was not tested by the inspector. Recommend locating the reason for trip and contacting a licensed electrician if necessary.**

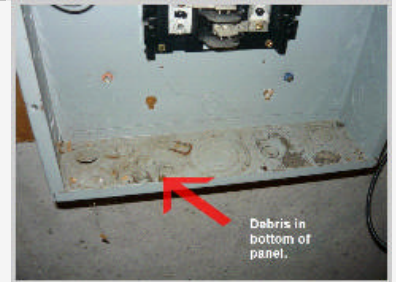
### 7.11 Panel Cover Removed:

Yes. Found minor amounts of debris in bottom of panel. Panel should be clean and free of all items except for wire routing.

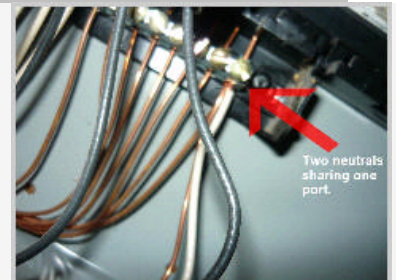
### 7.17 Wire Protection/Routing:

Satisfactory - Visible wiring appears to be installed in an acceptable manner. We did note that some of the neutral wires shares a port on the left bus bar (at the bottom) when they should have their own port. There were available ports at the top of this bus bar.

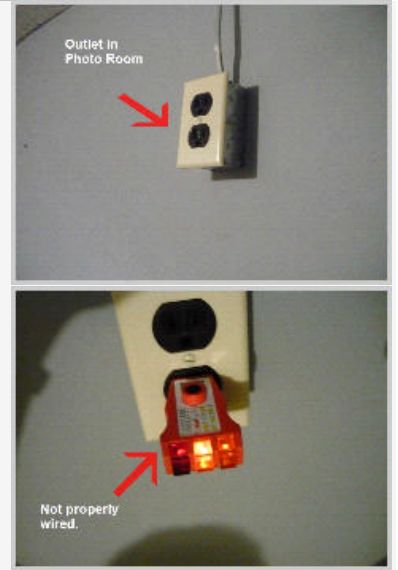
**7.21 Comments:**

The electrical box noted in the photo shop room was not properly grounded.

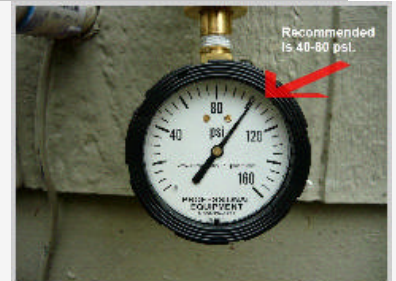
### 8.8 Water Pressure:

Water pressure was checked at an exterior hose bib. **Action Necessary - The water pressure is over 100 psi (102). Water pressure this high can cause damage to fill valves in toilets, dishwasher, and clothes washer. A water pressure regulator valve should be installed to regulate the pressure to an acceptable 40 to 80 psi range.**

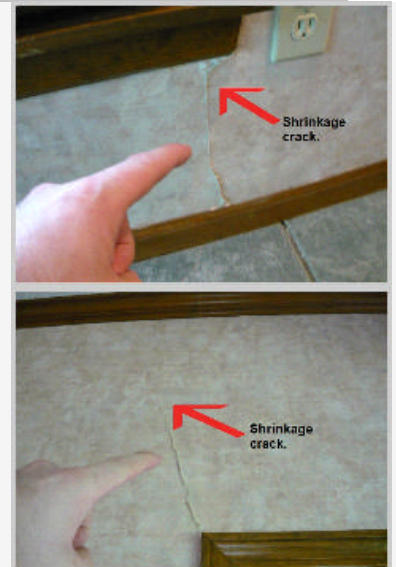
## 9.4 Walls:

Attention Needed - The walls in the kitchen show a condition that needs some attention. Some minor cracks were noted that do not appear to be a serious structural concern at this time. Be sure to take note of any future movement. Most minor cracking is due to shrinkage of the construction materials.

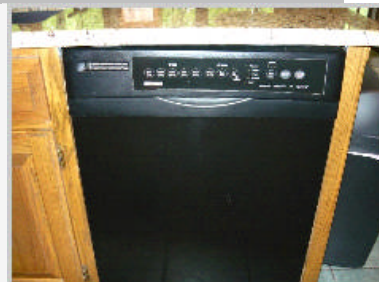
#### 9.15 Dishwasher:

Brand - Kenmore, black, relatively new in appearance. **There has been a manufacturer's recall of some Kenmore dishwashers. The units were sold in 1991 and 1992. Kenmore model numbers started with 665 and had Serial Numbers ranging from FA2400000 to 5299999 and FB0100000 through FB1899999. These units will be repaired or replaced by the manufacturer. Contact Sears at 1-800-927-1625 for additional information.** The dishwasher was not tested as was full of clean dishes. No comment is made regarding its functioning correctly.

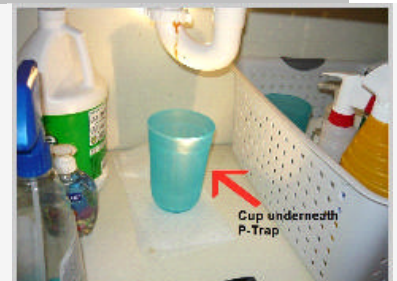
### 11.36 Sink and Drain Fixture:

Satisfactory - The basin and drainage fixture appears to be satisfactory. We did note that there was a cup located directly underneath the P-Trap in the guest bedroom bathroom area. There was no known leak though at the time of the inspection.

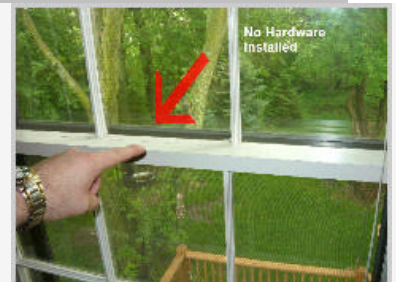
### 12.9 Windows:

Attention Needed - At least one window or associated hardware in this bedroom needs attention. Locking hardware needs repair or replacement as there is currently no hardware installed on the far left window.

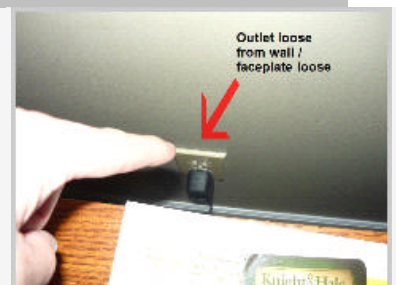
### 12.10 Electrical Outlets:

Satisfactory - The outlets tested in this bedroom are correctly wired and grounded. Attention Needed - At least one outlet noted needs to be refastened to the wall and face plate secured tightly. Located on the West wall behind the small chest cabinet.

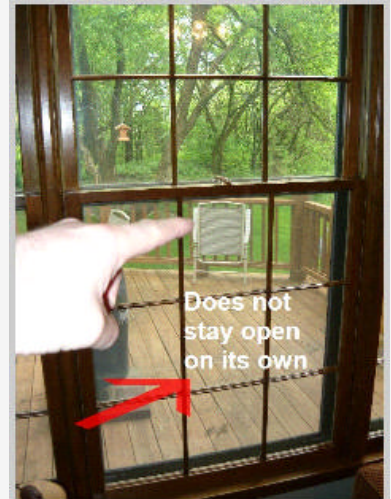
### 13.16 Windows:

Attention Needed - At least one window or associated hardware needs attention as the middle window did not stay open on its own when opened 1/4. This could potentially fall onto a child or a pet if opened and not supported.

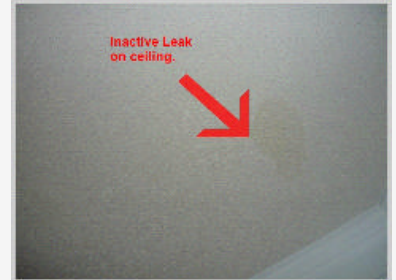
### 13.30 Ceiling:

Attention Needed - There is a condition in the ceiling that needs attention. There is evidence of an unrepaired stain on the wall caused by a prior moisture leak.

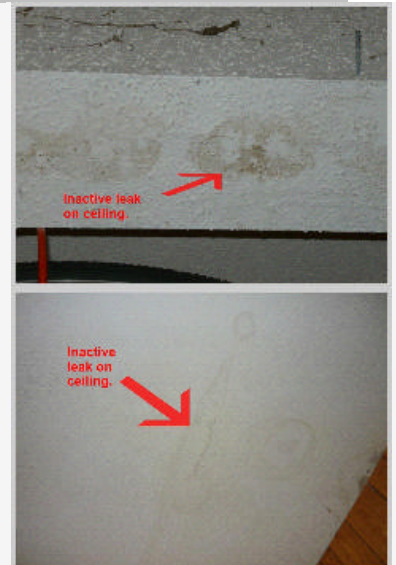
## 14.9 Fire Rated Ceiling:

I was unable to determine if the installed sheetrock is fire rated. **Previous Leak - There are signs of a previous water leak in the ceiling in this room. It does not appear to be an active leak.**
