# HOME CONDITION REPORT

15225 Hardy St. Overland Park, KS

Inspection Date: 07/04/2005

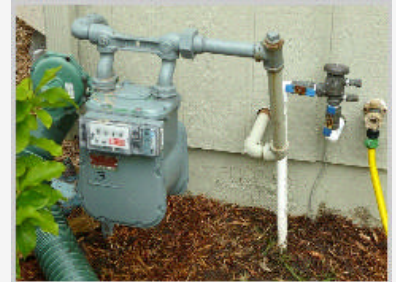
**2.24 Fuel Source:**

Natural gas is provided by a regulated service company or utility.

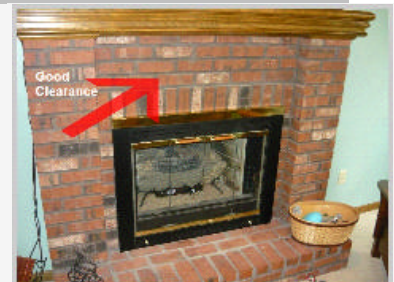
### 5.35 Type of Fireplace:

Metal Firebox - There is a masonry fireplace installed with a metal formed firebox.

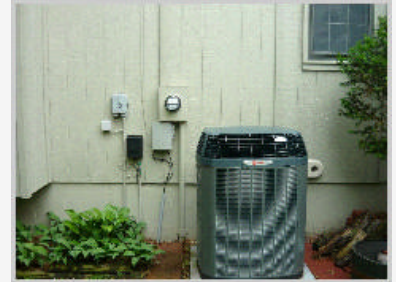
### 6.1 Model/ Serial Number/ Size:

Brand - Trane ; Model #XL 16I ; Serial #8474HU1F ; This unit was manufactured 11/2008.

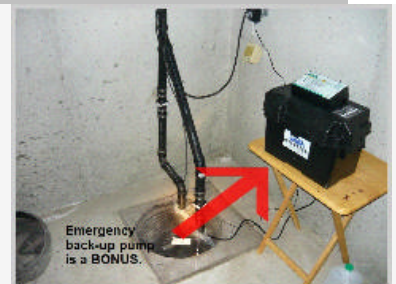
### 8.24 Sump Pump:

Yes - The sump pump installed is functional. The presence of a sump pump does not indicate there is a need for it. This inspection does not verify the existence of or effectiveness of any subslab or perimeter drainage system. There is a submersible type sump pump installed. There is a battery backup installed. This will be of benefit should the electric fail, especially during a rainstorm.

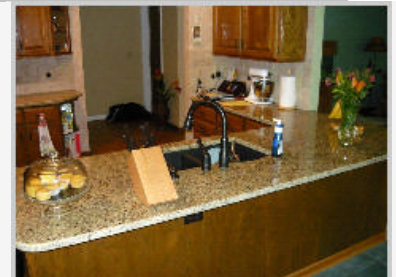
## 9.9 Countertops:

The countertops in the kitchen appear to be new, and they should provide years of service.
